U.S. NAVY SALVAGE REPORT

USS *MISSISSINEWA*

OIL REMOVAL OPERATIONS

MAY 2004

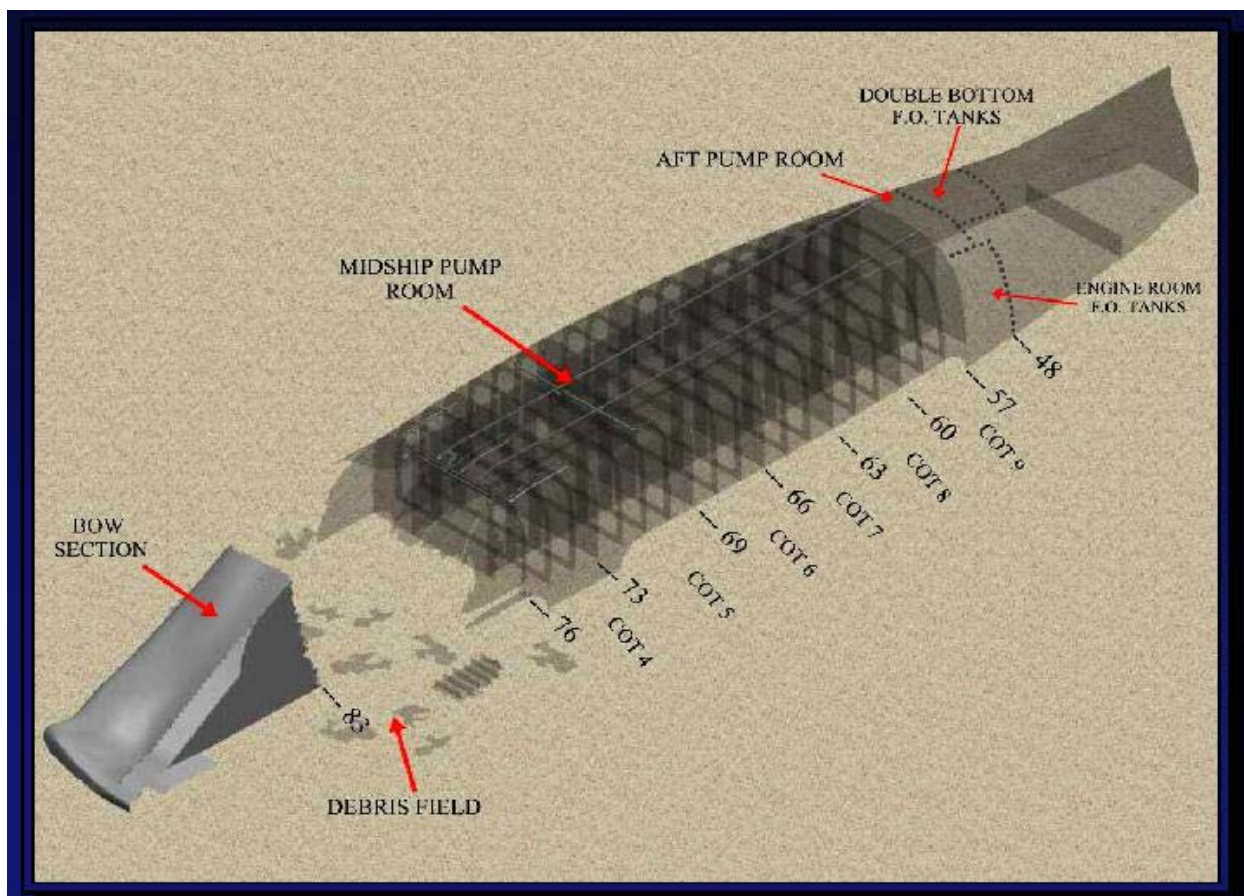
Figure 1-1. *Mississinewa*, Showing Tank Locations and Condition

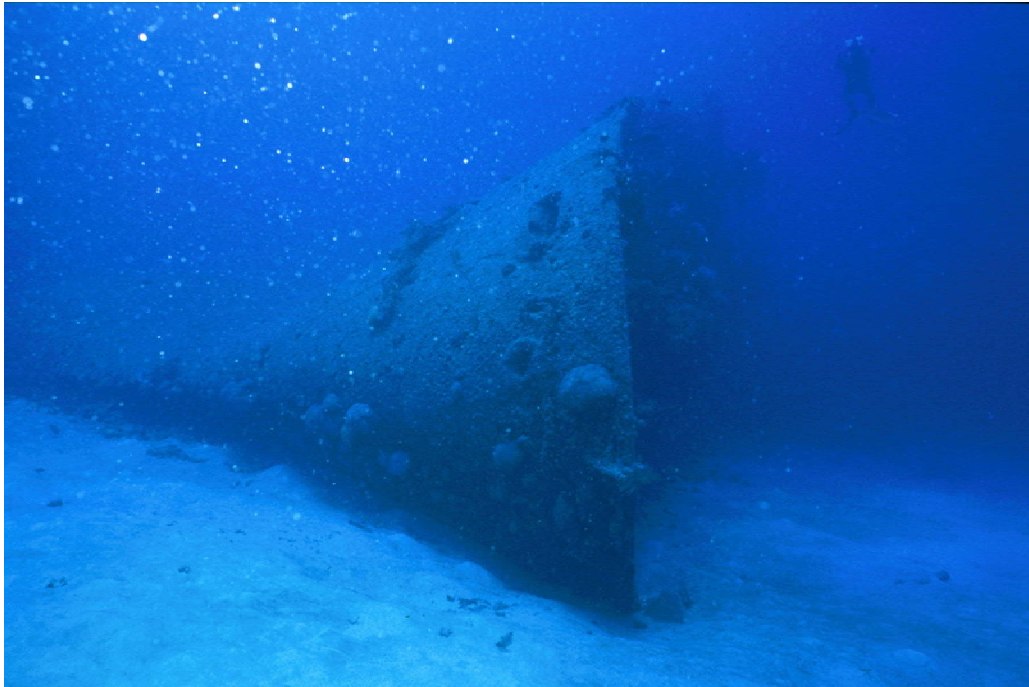
Figure 2. *Mississinewa*'s Bow

The wreck lies in about 130 feet of water in the Ulithi Lagoon. The hull is broken in two parts. The bow is intact and lying on its port side (see Figure 2). This bow section extends from the Forward Perpendicular (FP) about 85 feet aft to the first Cofferdam at frame (Fr) 83. The starboard side of the Fore Peak and Reserve Fuel Oil/ Saltwater Ballast (FO/SWB) Tanks from Fr-84 to 102 appear to be intact. Depth of the bow at the sand line varied from 127 to 133 feet.

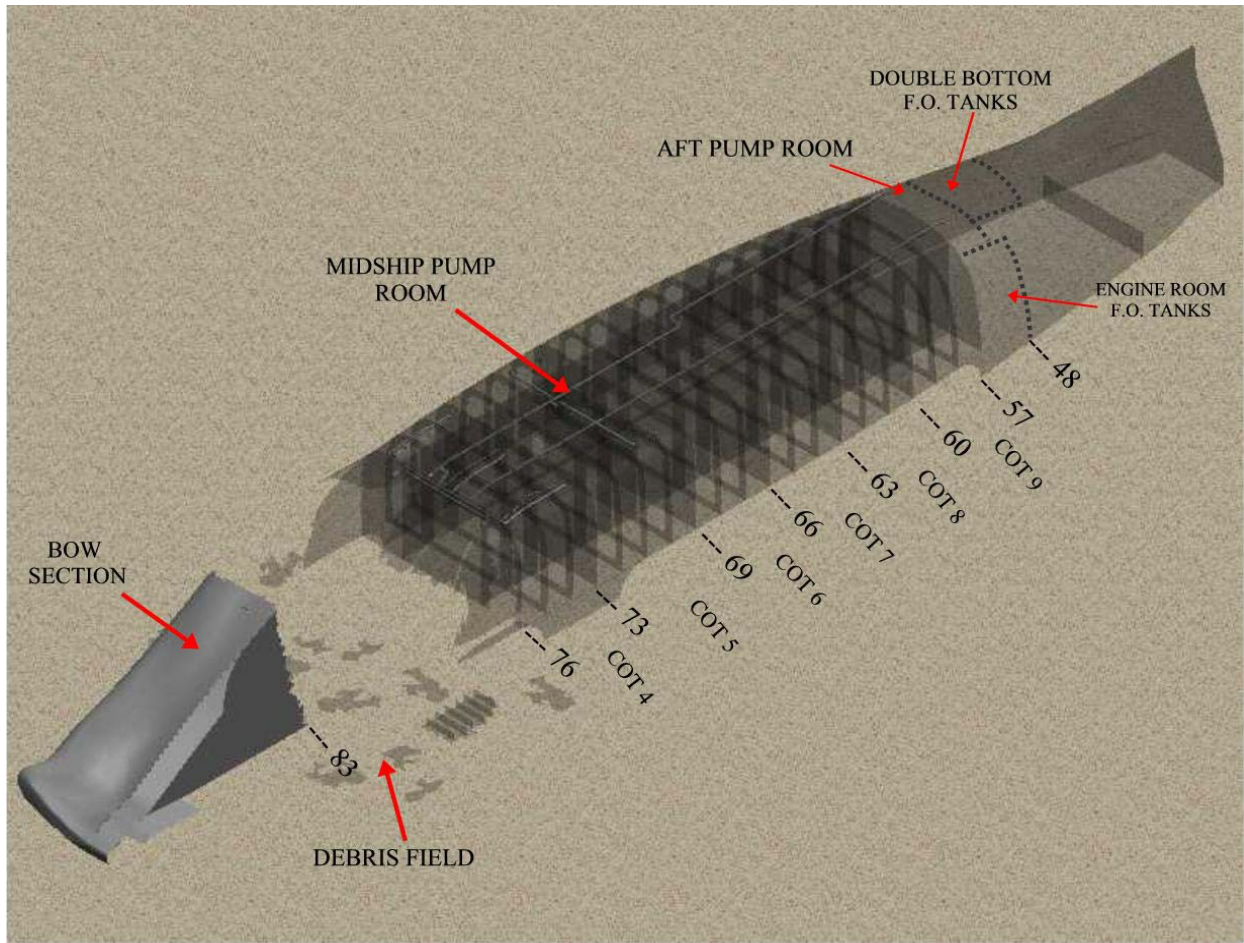
Figure 3. Overview of *Mississinewa*

Continuing the survey aft of Oil Tight Bulkhead (OTB) 76, the hull is intact to its stern but is completely upside down. Diver measurements of hull attitude as she lies are 3 degrees down by the bow (i.e., the keel slopes downward from the AP forward to OTB-76) and 5 degrees list to the port side (i.e., the wreck's port side is about 4 feet lower than the starboard side). A sandline survey on the wreck's starboard side indicates that the deck edge is visible and not buried in the sand. Therefore, the main hull appears to rest on the Midship Island superstructure and Poop

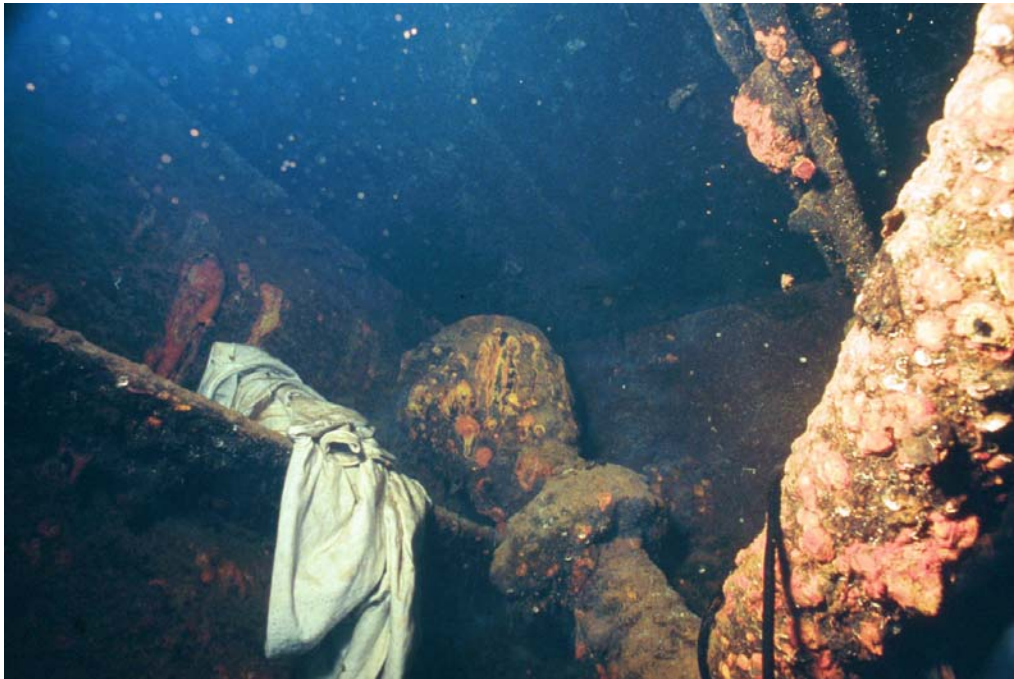
Figure 4. COT 4-S, Bellmouth Oil Leak Source

Further inspection determined that the region from OTB-76 forward to OTB-83 (i.e., COTs 1, 2 and 3) is destroyed and only twisted rubble exists for this span of tanks. There is an overhanging portion of bottom shell plating bent downward and extending some 30 feet forward of OTB-76. This plating contained the crack in way of COT 4-S that was originally identified by the Yap scuba divers as the leak source. Interior dives under the overhang and into the tank itself revealed that the actual leak emanated from the bellmouth at the 4-inch stripping line suction (see Figure 4). This bellmouth was plugged with rags and capped with concrete, thus stopping the leak.

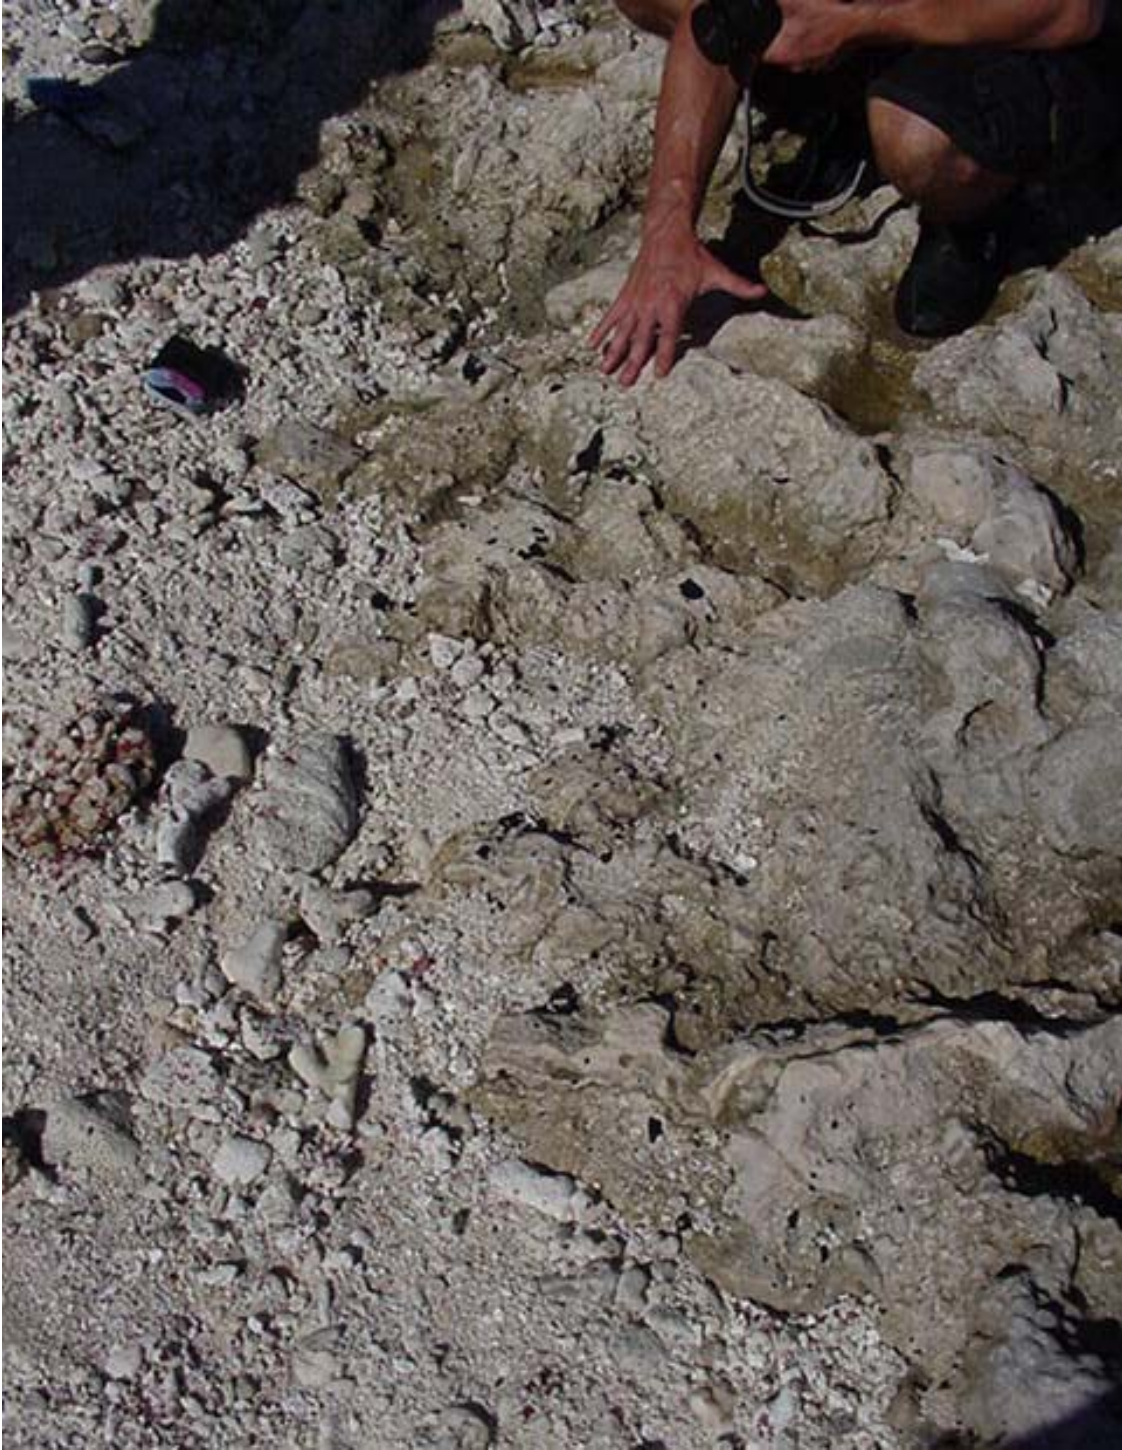
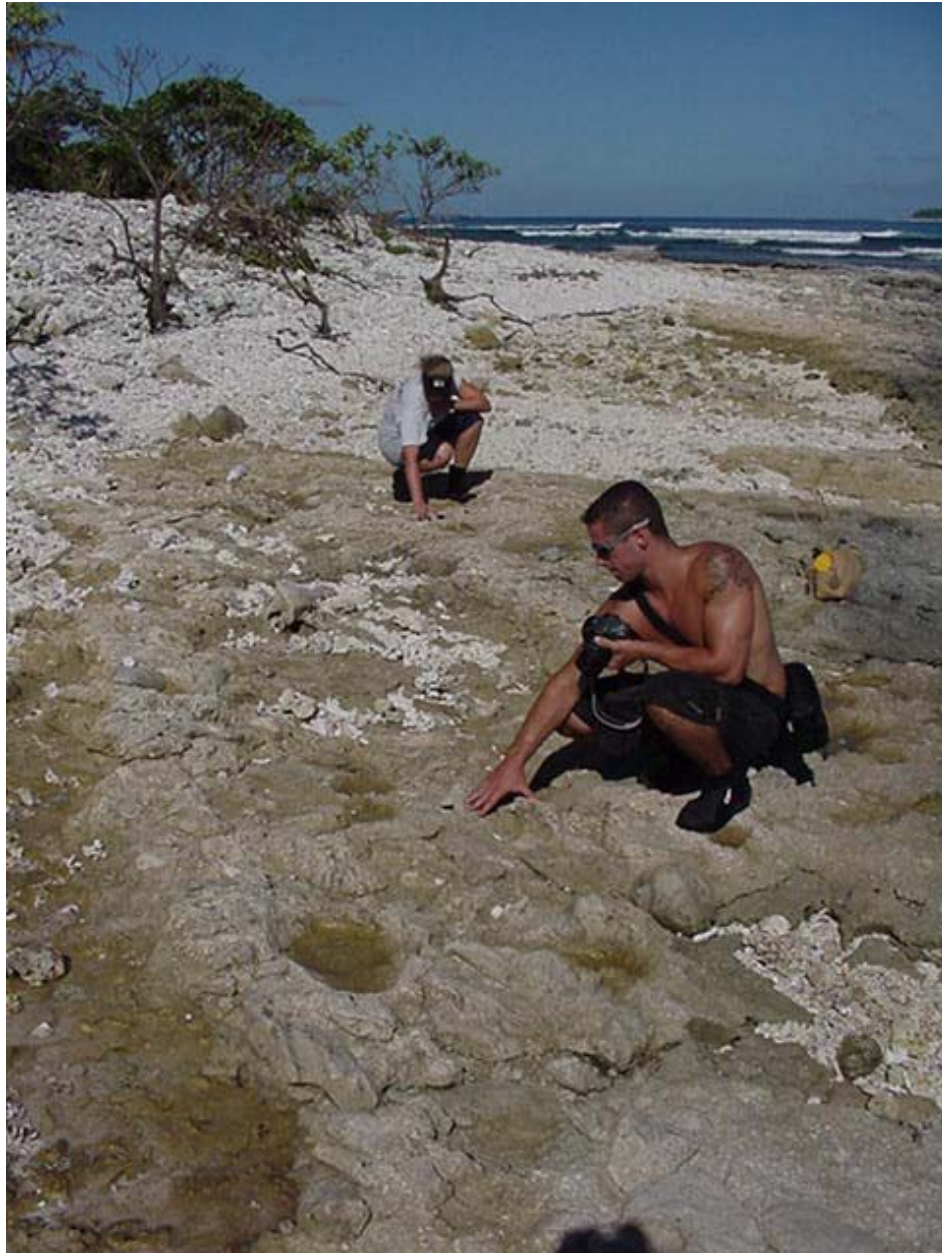
between the patches was from 3 feet to 10 feet distributed along approximately 100 yards of beach. Examples of this oil distribution are shown in Figures C-3 and C-4.

Figure C-3. Detail of Oil Deposits on Southeast Beach Ledge – Asor Island

Figure C-4. Overview of Oil Deposits on Southeast Beach Ledge – Asor Island

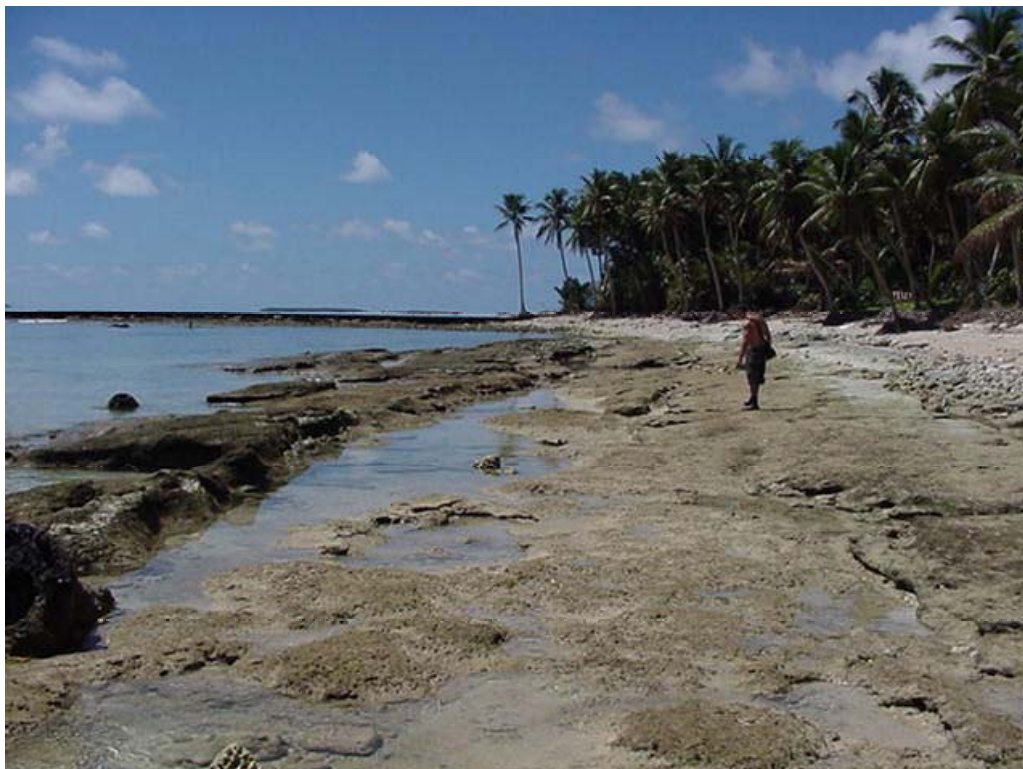
The old landing craft ramp area on the south beach had an old steel dock that extended out into the water, as shown in Figure C-6. The dock was severely deteriorated and contained numerous pockets that could have trapped oil in a receding tide. No oil was found to be trapped in these pockets.

Figure C-6. Asor Island South Beach Area – Landing Craft Dock (upper left)

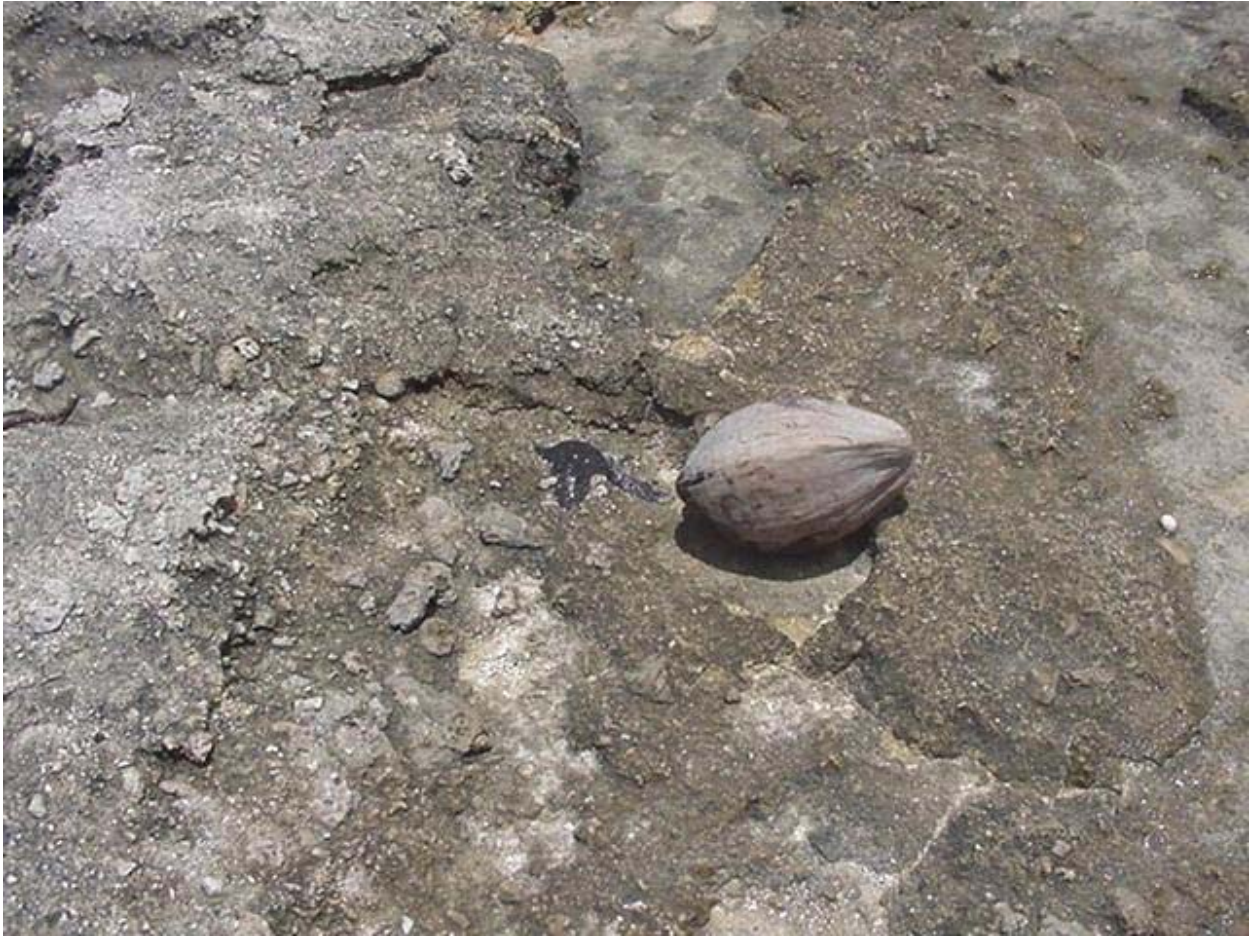
The few tidal pools found were mostly clear and free of oil. Any oil found was in advanced stages of weathering. See Figure C-8 showing an oil patch approximately 4 inches across.

Figure C-8. Losiep Island Weathered Oil Deposit
